NATIONAL PROGRAM FOR INSPECTION OF NON-FEDERAL DAMS  
GALE MEADOWS DAM (VT (U) CORPS OF ENGINEERS WALTHAM MA  
NEW ENGLAND DIV MAR 80

GAIA MEADOWS DAM VT 00115

MAR 1980

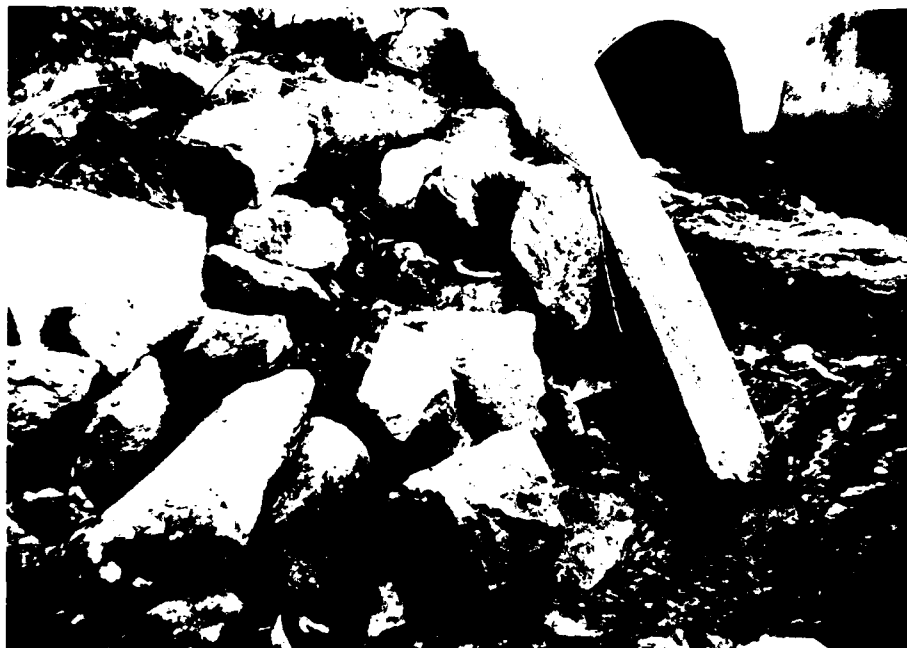
C-4A Seep at right wingwall of service spillway outlet structure.  
11/19/79
